Caltrans Division of Research,
Innovation and System Information

Project Title:
Load Testing Bay Bridge
Expansion Joints

Load Testing Bay Bridge Expansion Joints

Testing whether a new type of thermal and seismic expansion joint can withstand heavy traffic on the Bay Bridge

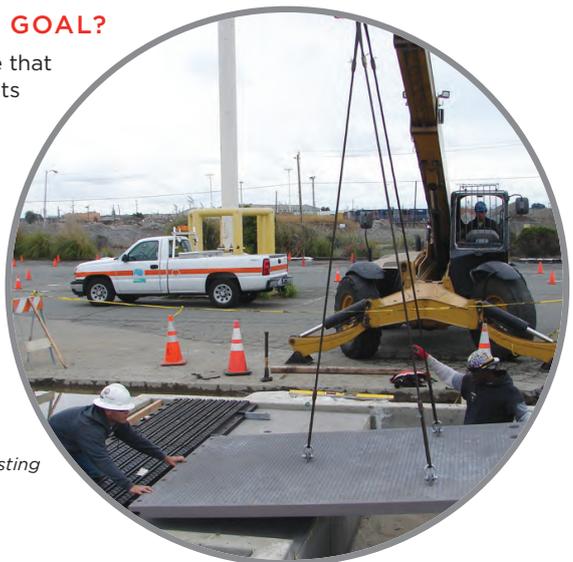
Workers assembling the mock-up joint for testing

A test structure incorporating a full-scale joint was constructed close to the bridge. A total of 1.36 million load repetitions, equating to about 46 million standard axle loads on a highway pavement, were applied in seven phases during the three-month test. During this test, no seismic or structural testing was undertaken.

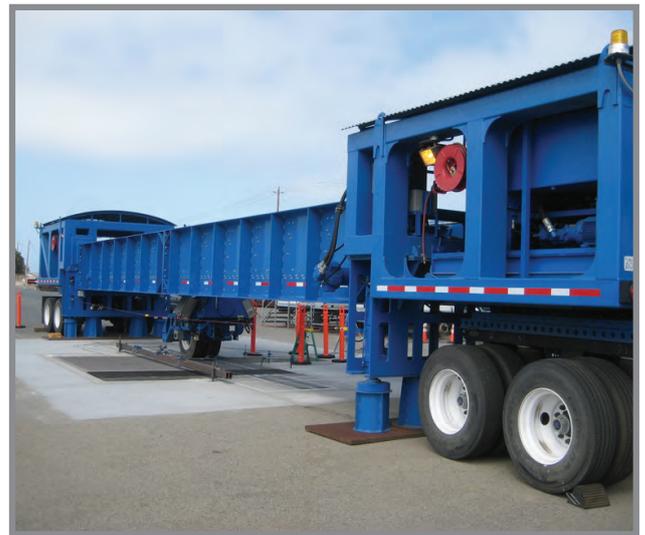
HVS testing on the deck joint

Caltrans, in partnership with the University of California Pavement Research Center, used an HVS to gain a quick indication of how the joints would perform under truck traffic.
